Sheikh İbrahim Mausoleum

The mausoleum of Sheikh İbrahim is located in the cemetery of the village of Ashagy Aybasanly in Fuzuli district of Azerbaijan. Among the local residents, the monument is known as the “Tomb of Iba” or “Mausoleum of Iba İbrahim”.

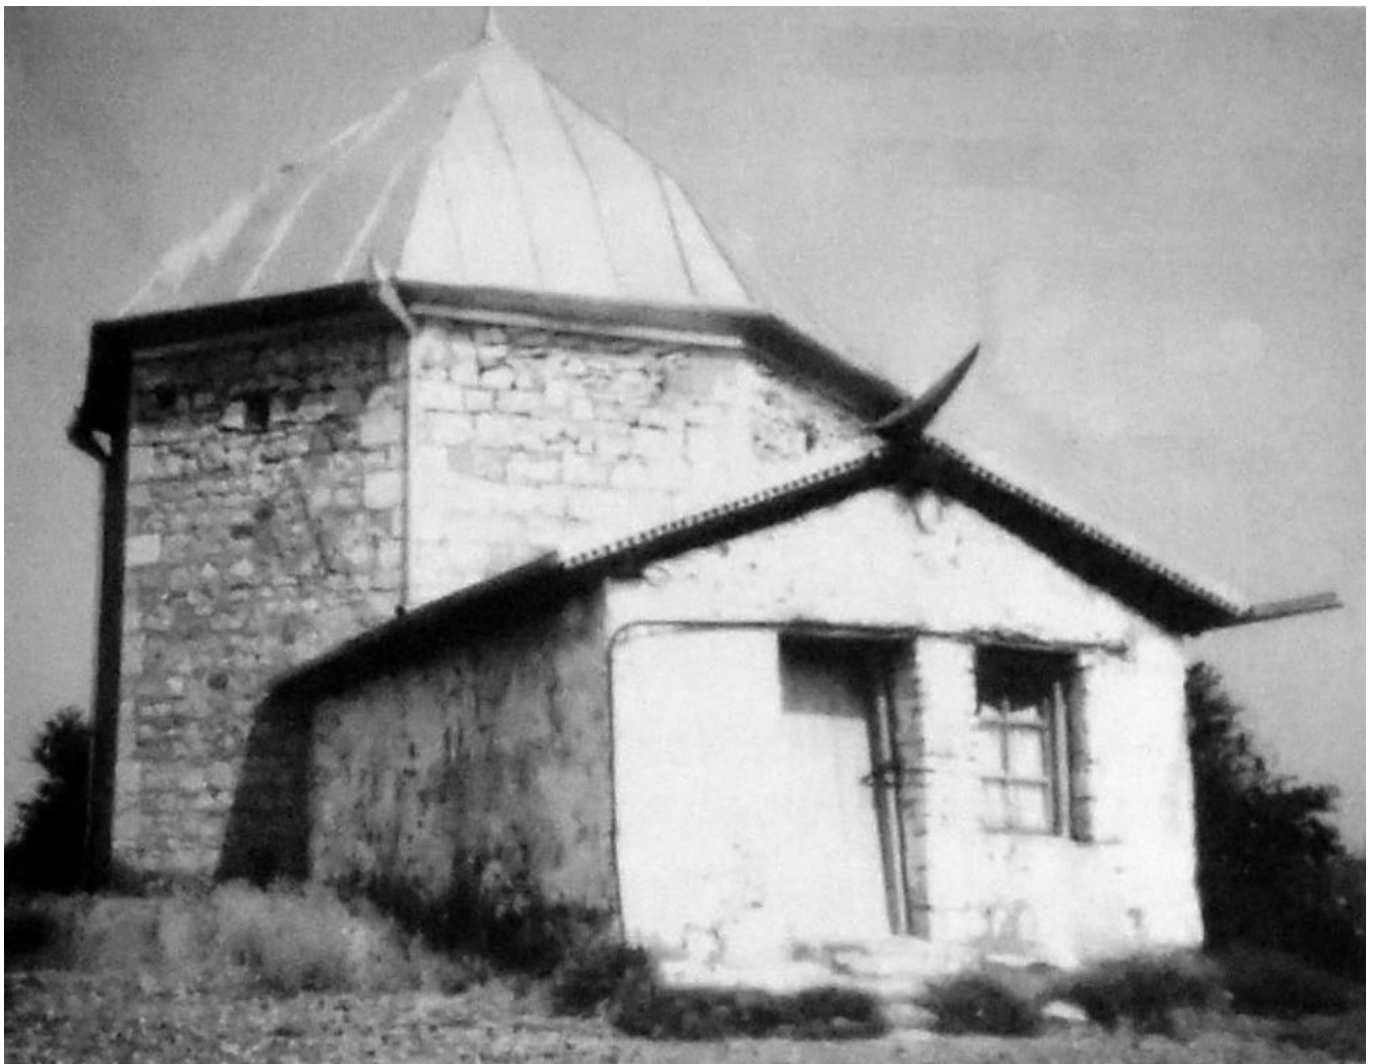
The plan of the mausoleum is octagonal from the outside, and the inner wall has a smooth round shape plastered with lime mortar. The mausoleum was built of lime stone, and its dome is made of baked brick. The interior of the mausoleum is dimly illuminated from five sides by small windows located closer to its dome.

The entrance to the mausoleum is located on the east and ends

with a pointed arch. The height of the doorway is 1.5 m, and the width is 0.73 m. In the upper left corner of the doorway of the mausoleum there was carved a woman standing under a tree and next to her was depicted a horse.

“However, at the beginning of the XX century, the center of the dome, which was subjected to natural and artificial destruction, collapsed. Later, with the help of local residents, the upper part of the tomb was again covered with a reinforced concrete dome, without touching the dilapidated dome itself. (This is clearly visible from the ceiling of the mausoleum’s interior). However, since this coating did not retain natural water, it was coated on the outside with a layer of stainless non-ferrous white metal. The metal coating does not let natural water into the center of the tomb, but completely modernizes the monument, spoiling its architecture and former appearance.”

With the occupation of Fuzuli by Armenian armed groups in 1993, the mausoleum was vandalized. The outer metal covering and the corridor adjacent to the mausoleum were destroyed.
